**FINAL REPORT  
INSTALLATION RESTORATION  
PROGRAM  
PHASE II — CONFIRMATION  
EDWARDS AFB, CALIFORNIA**

PREPARED FOR  
**U.S. AIR FORCE  
OCCUPATIONAL AND ENVIRONMENTAL  
HEALTH LABORATORY  
BROOKS AFB, TEXAS**

SEPTEMBER 1982

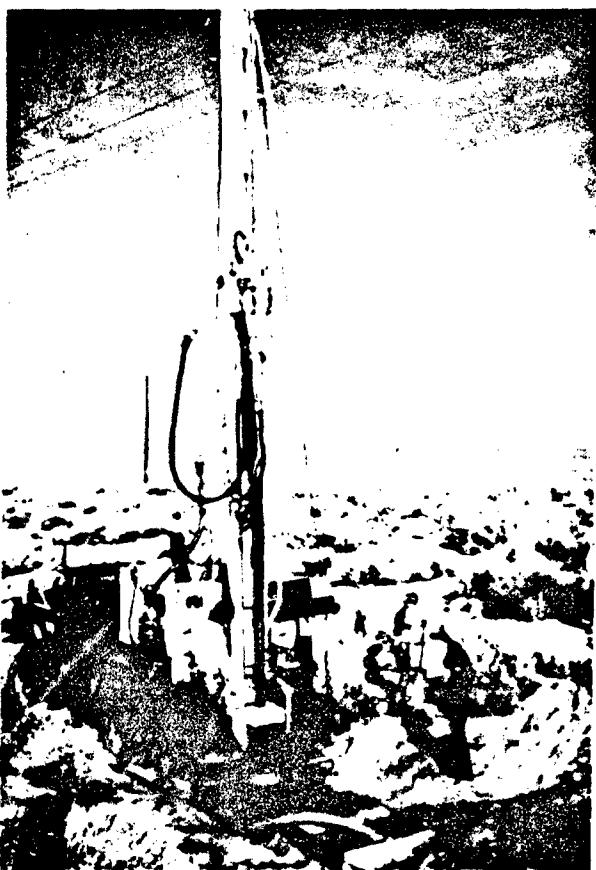
**PHOTO A**  
Rotary-wash drilling at Site  
1A

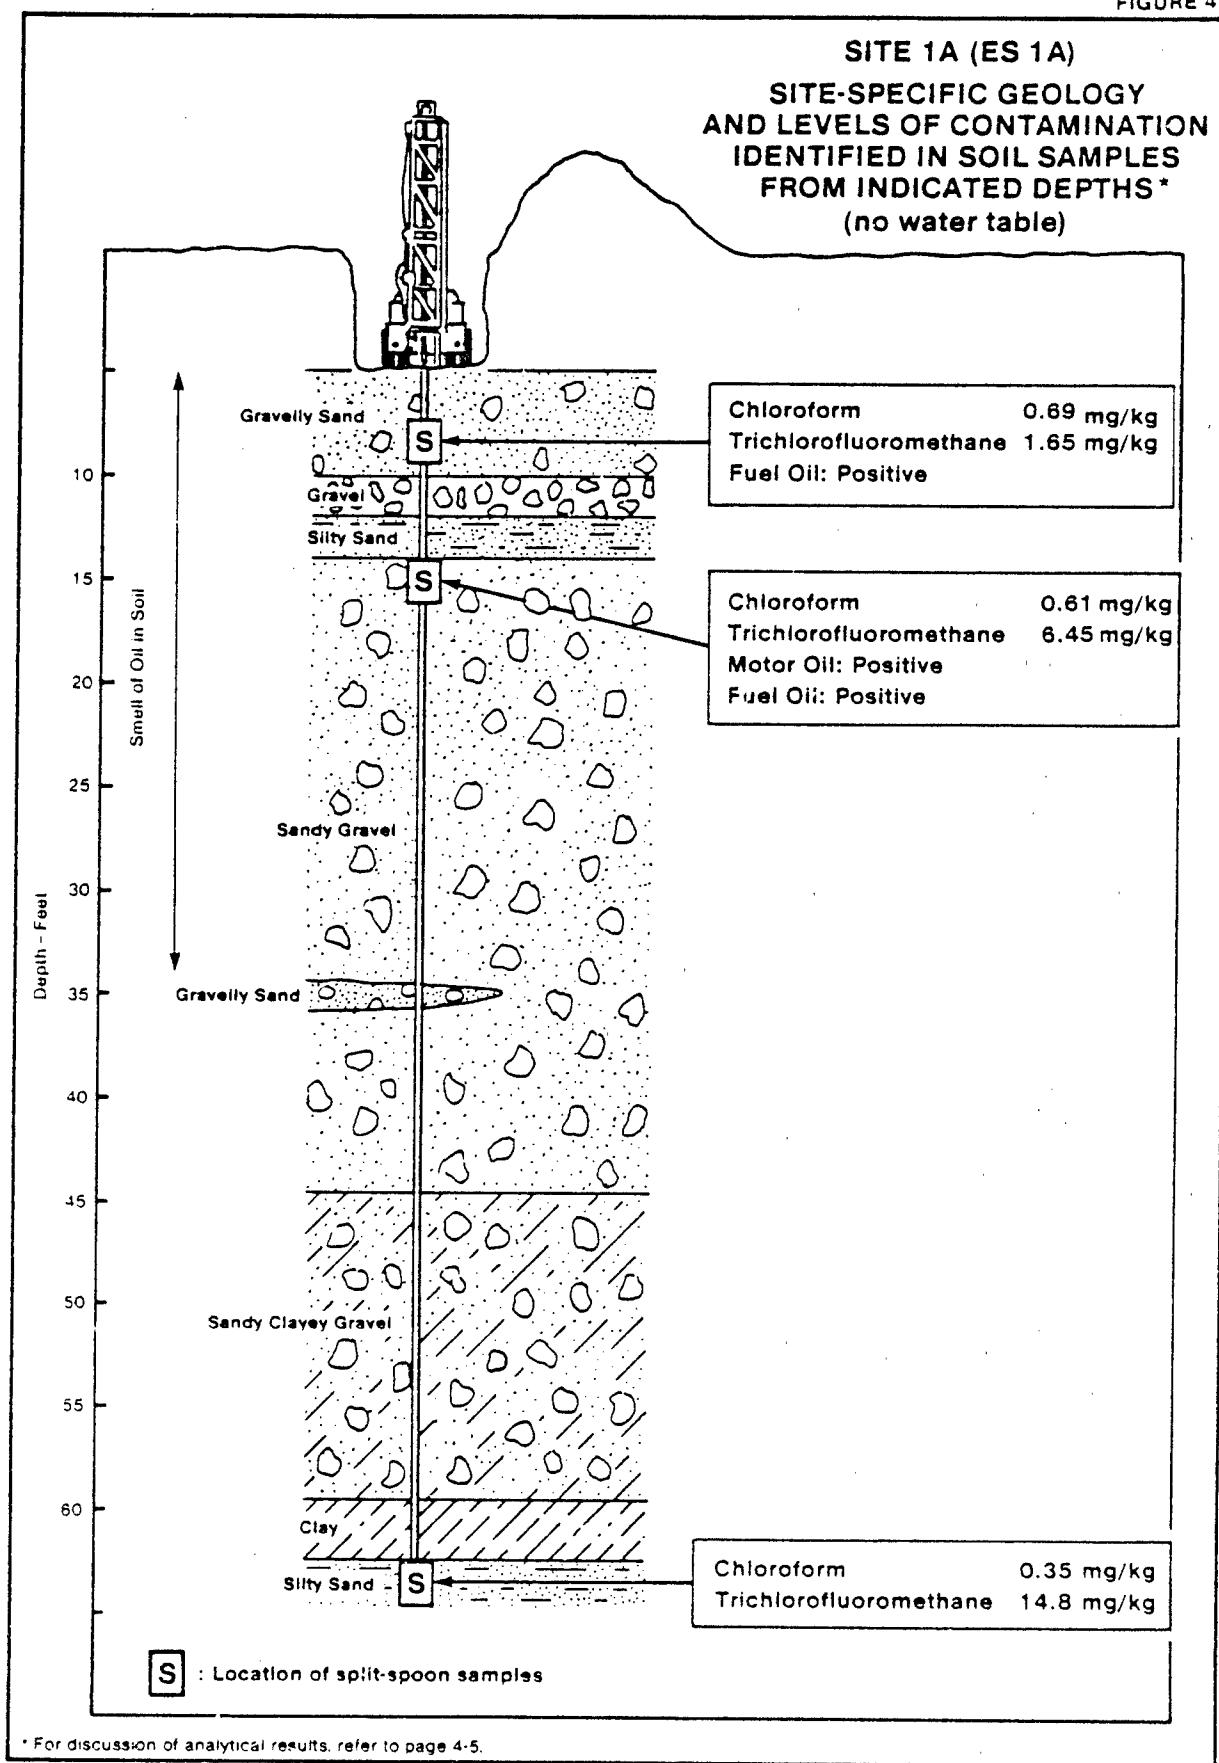
FIGURE 4.1

constituents were detected at various sites and depths. Inspection of Figures 4.1 through 4.5 also indicates that soil contamination is not limited to areas immediately underlying the disposal sites (1D1 and 1D2), but is present in the surficial soils at least 25 feet away from the actual disposal area. At all North Base sites, soil samples from the greatest depths (55 feet to 61 feet) showed chemical constituents present in detectable concentrations. Groundwater was not encountered in any of the soil borings.

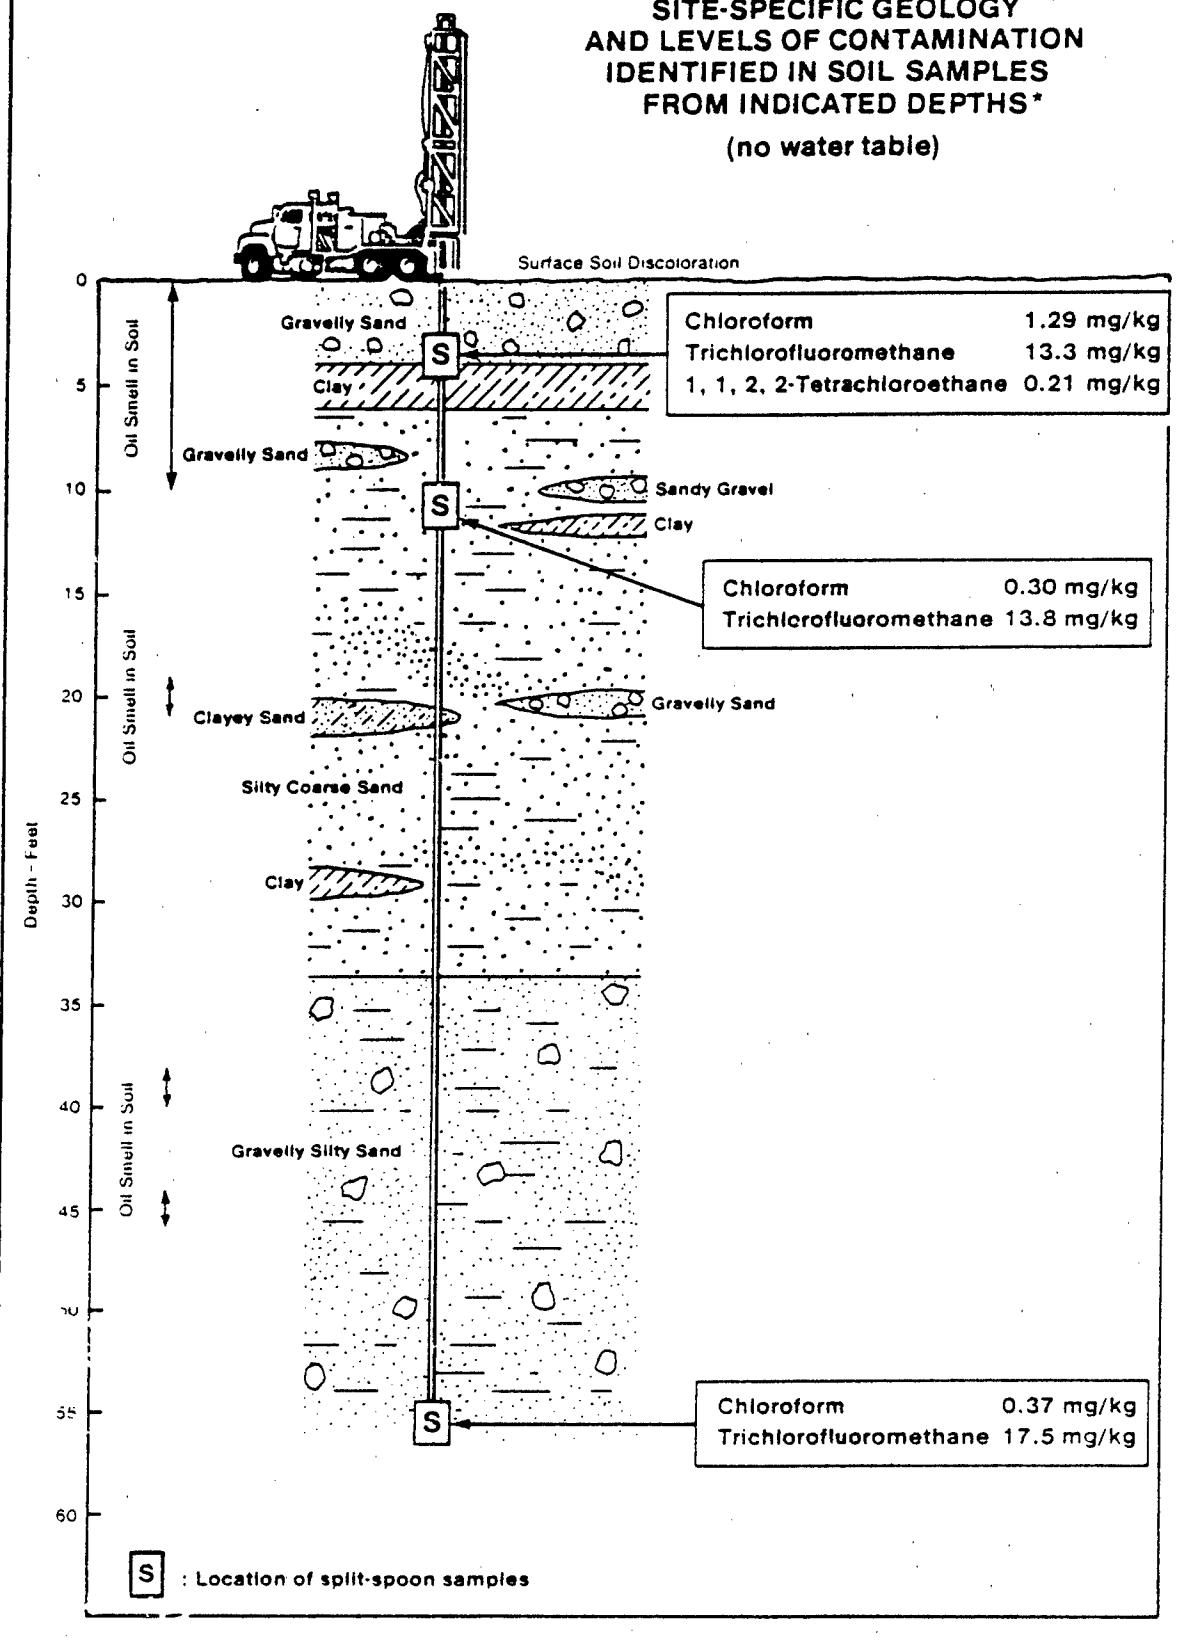
FIGURE 4.2

**SITE 1B (ES 1B)**  
**SITE-SPECIFIC GEOLOGY**  
**AND LEVELS OF CONTAMINATION**  
**IDENTIFIED IN SOIL SAMPLES**  
**FROM INDICATED DEPTHS\***

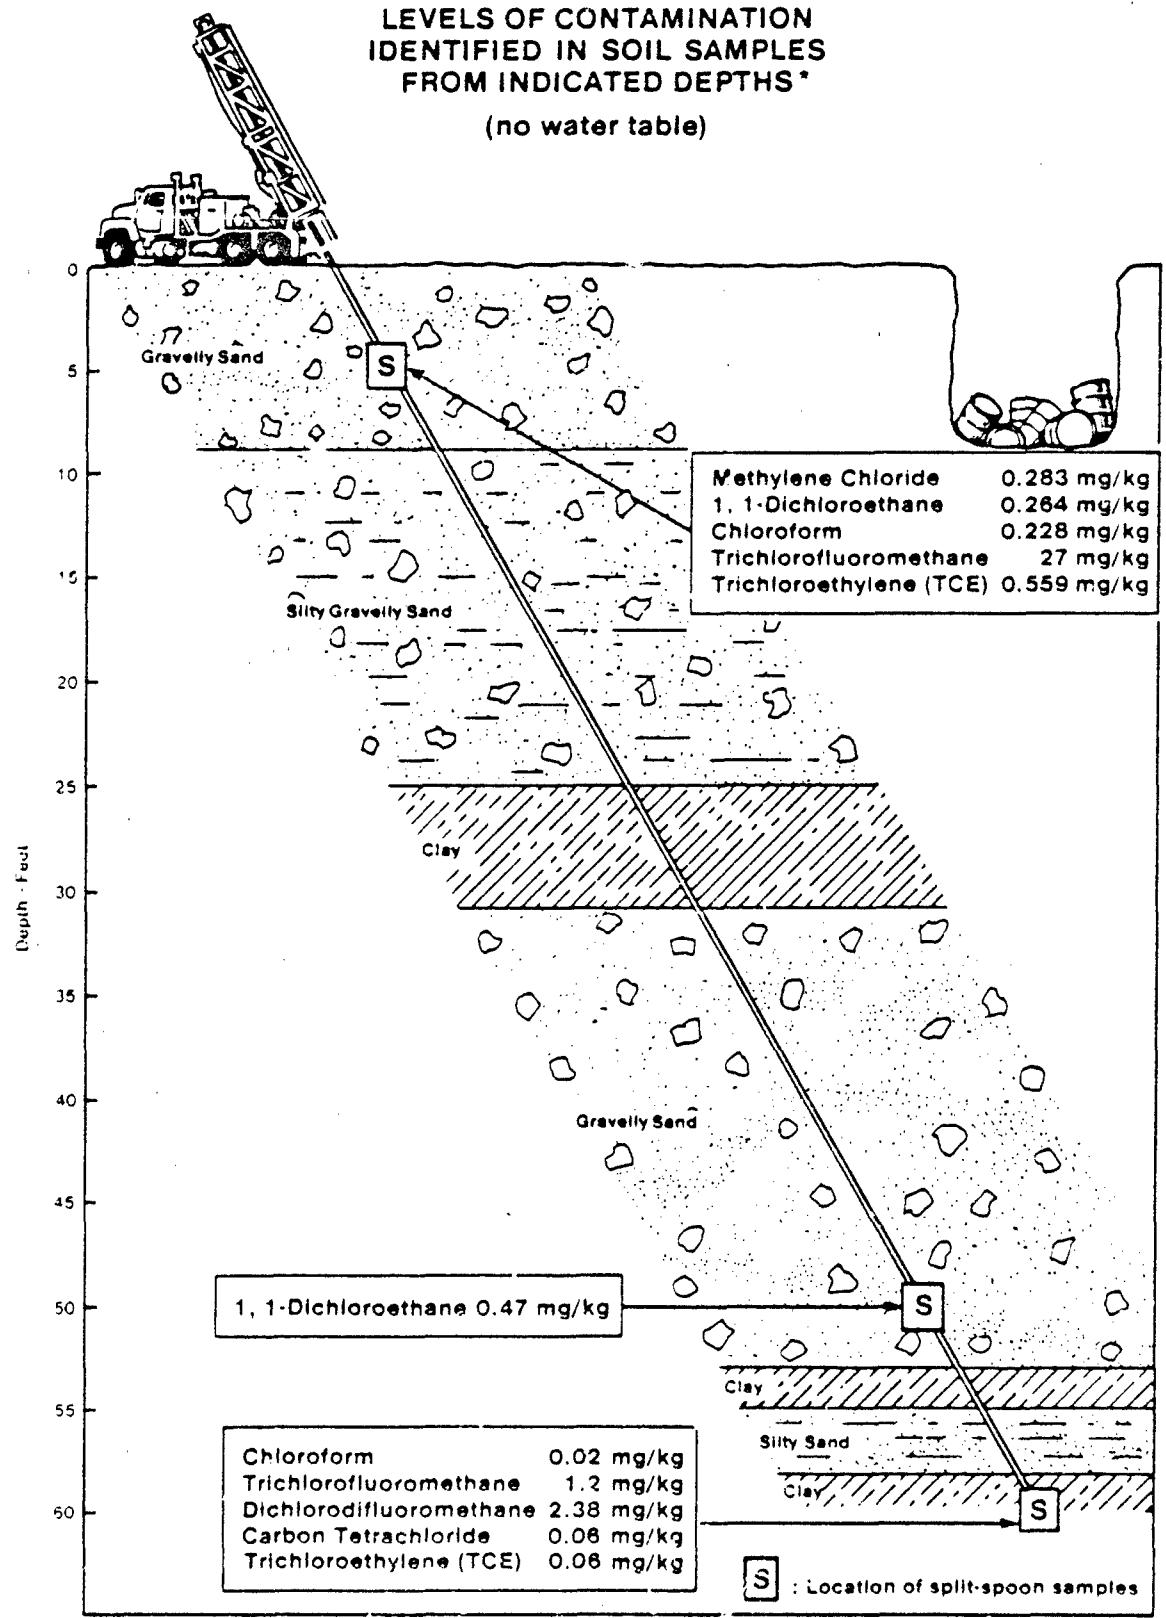
**SITE 1D2 (ES 1D2)**  
**SITE-SPECIFIC GEOLOGY AND**  
**LEVELS OF CONTAMINATION**  
**IDENTIFIED IN SOIL SAMPLES**  
**FROM INDICATED DEPTHS\***

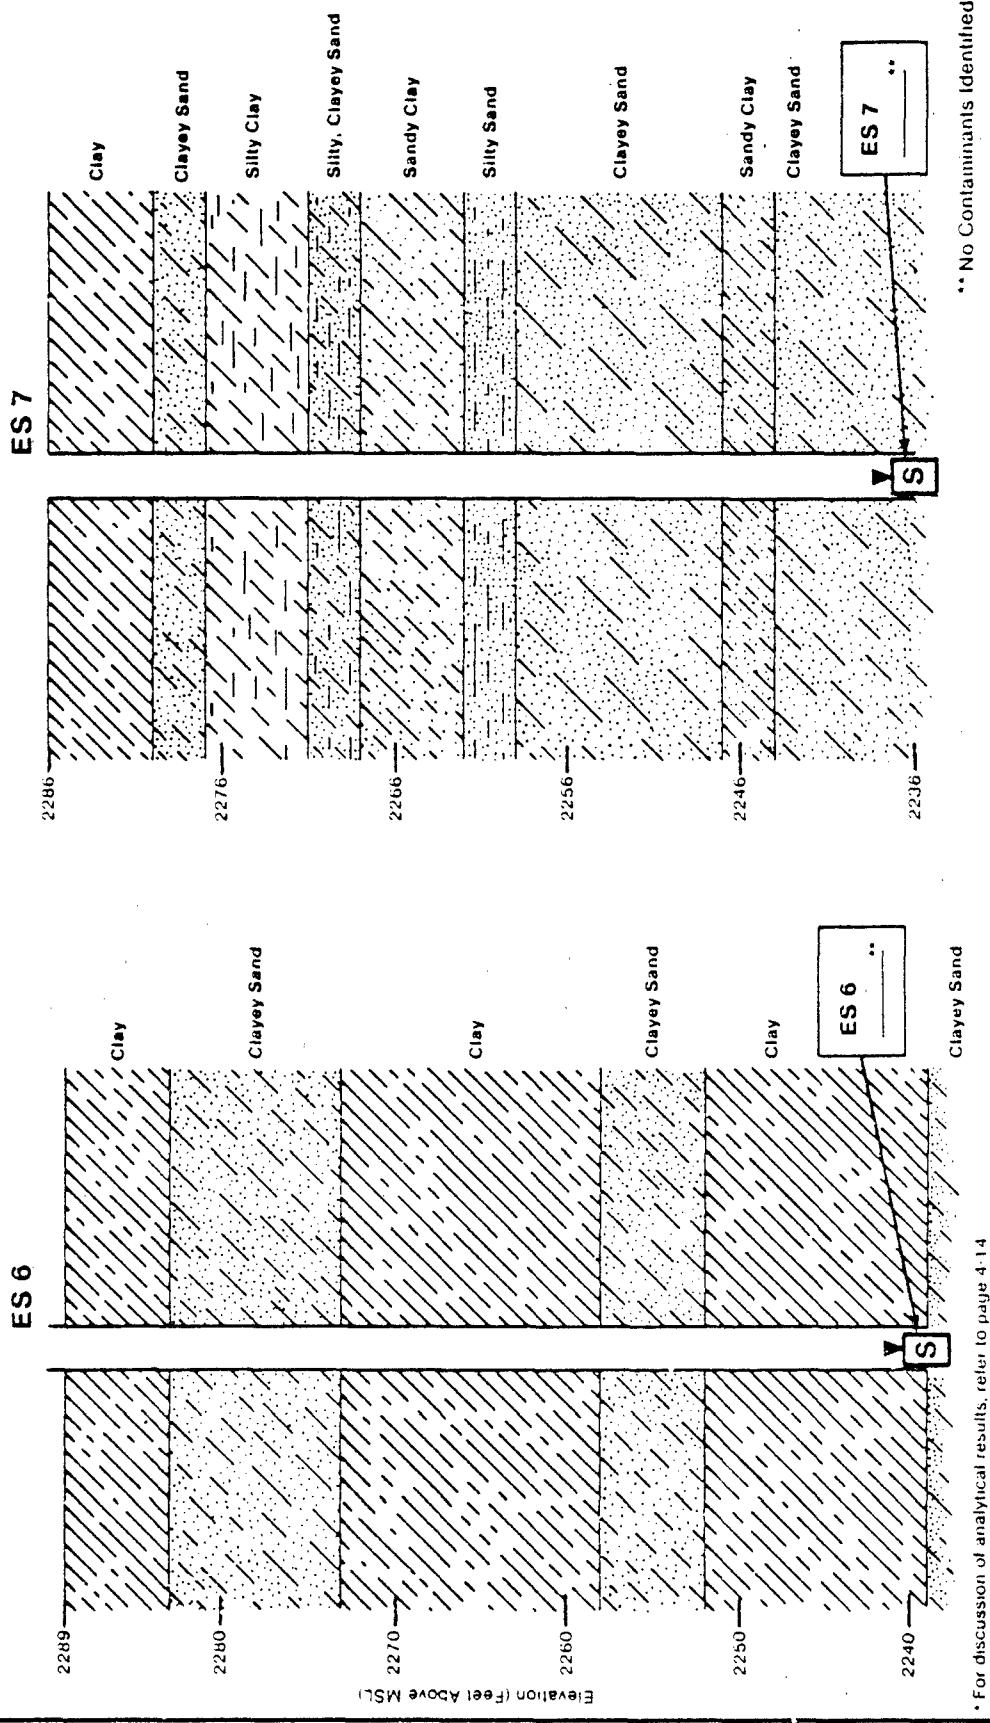
FIGURE 4.9

**SITE 5**  
**SITE-SPECIFIC GEOLOGY AND**  
**LABORATORY RESULTS OF**  
**IDENTIFIED CONTAMINANTS IN**  
**SAMPLED GROUNDWATER.**

\*\*No Contaminants Identified

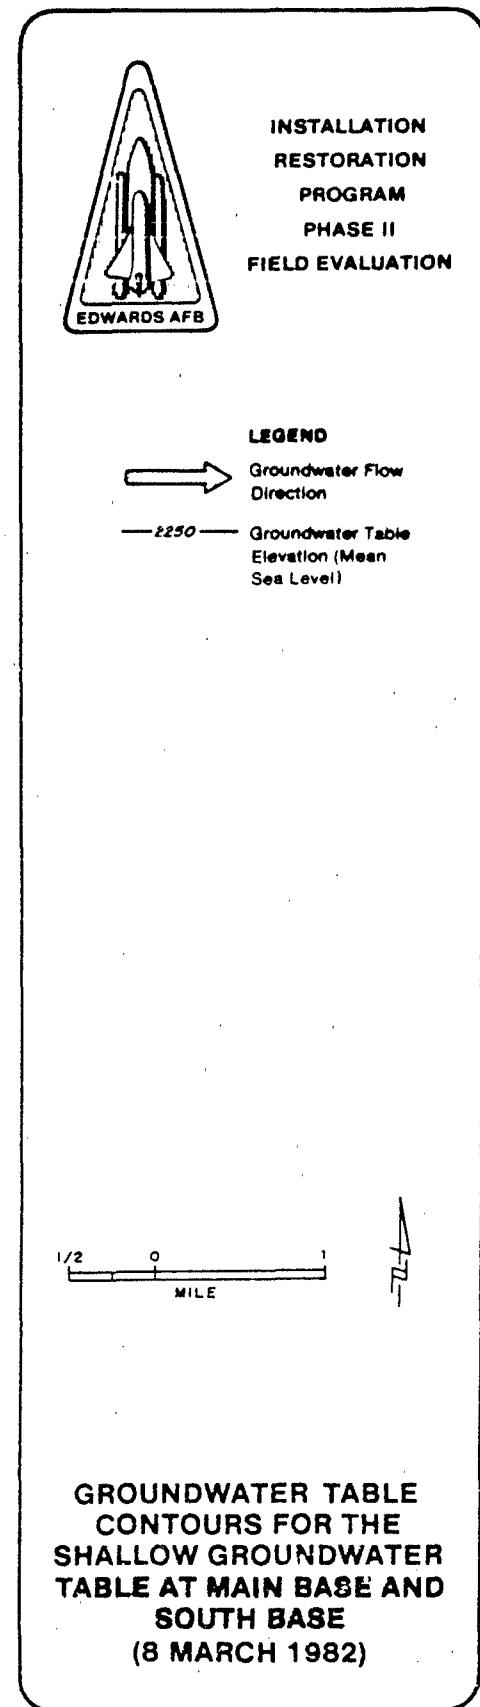
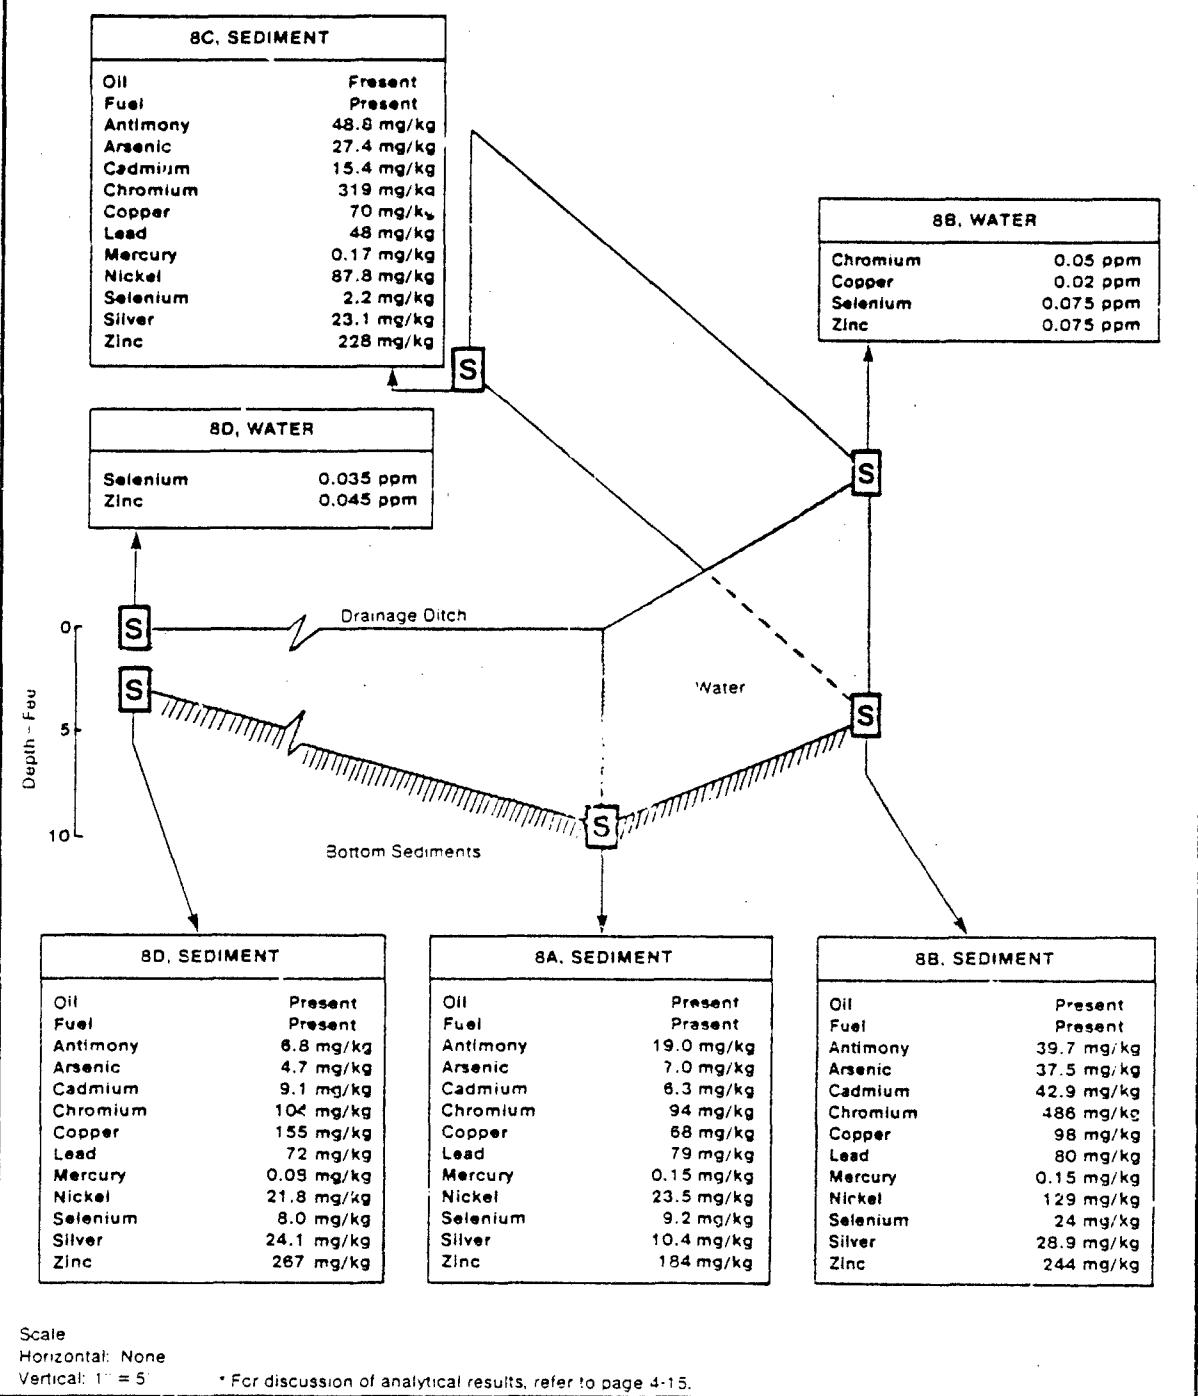
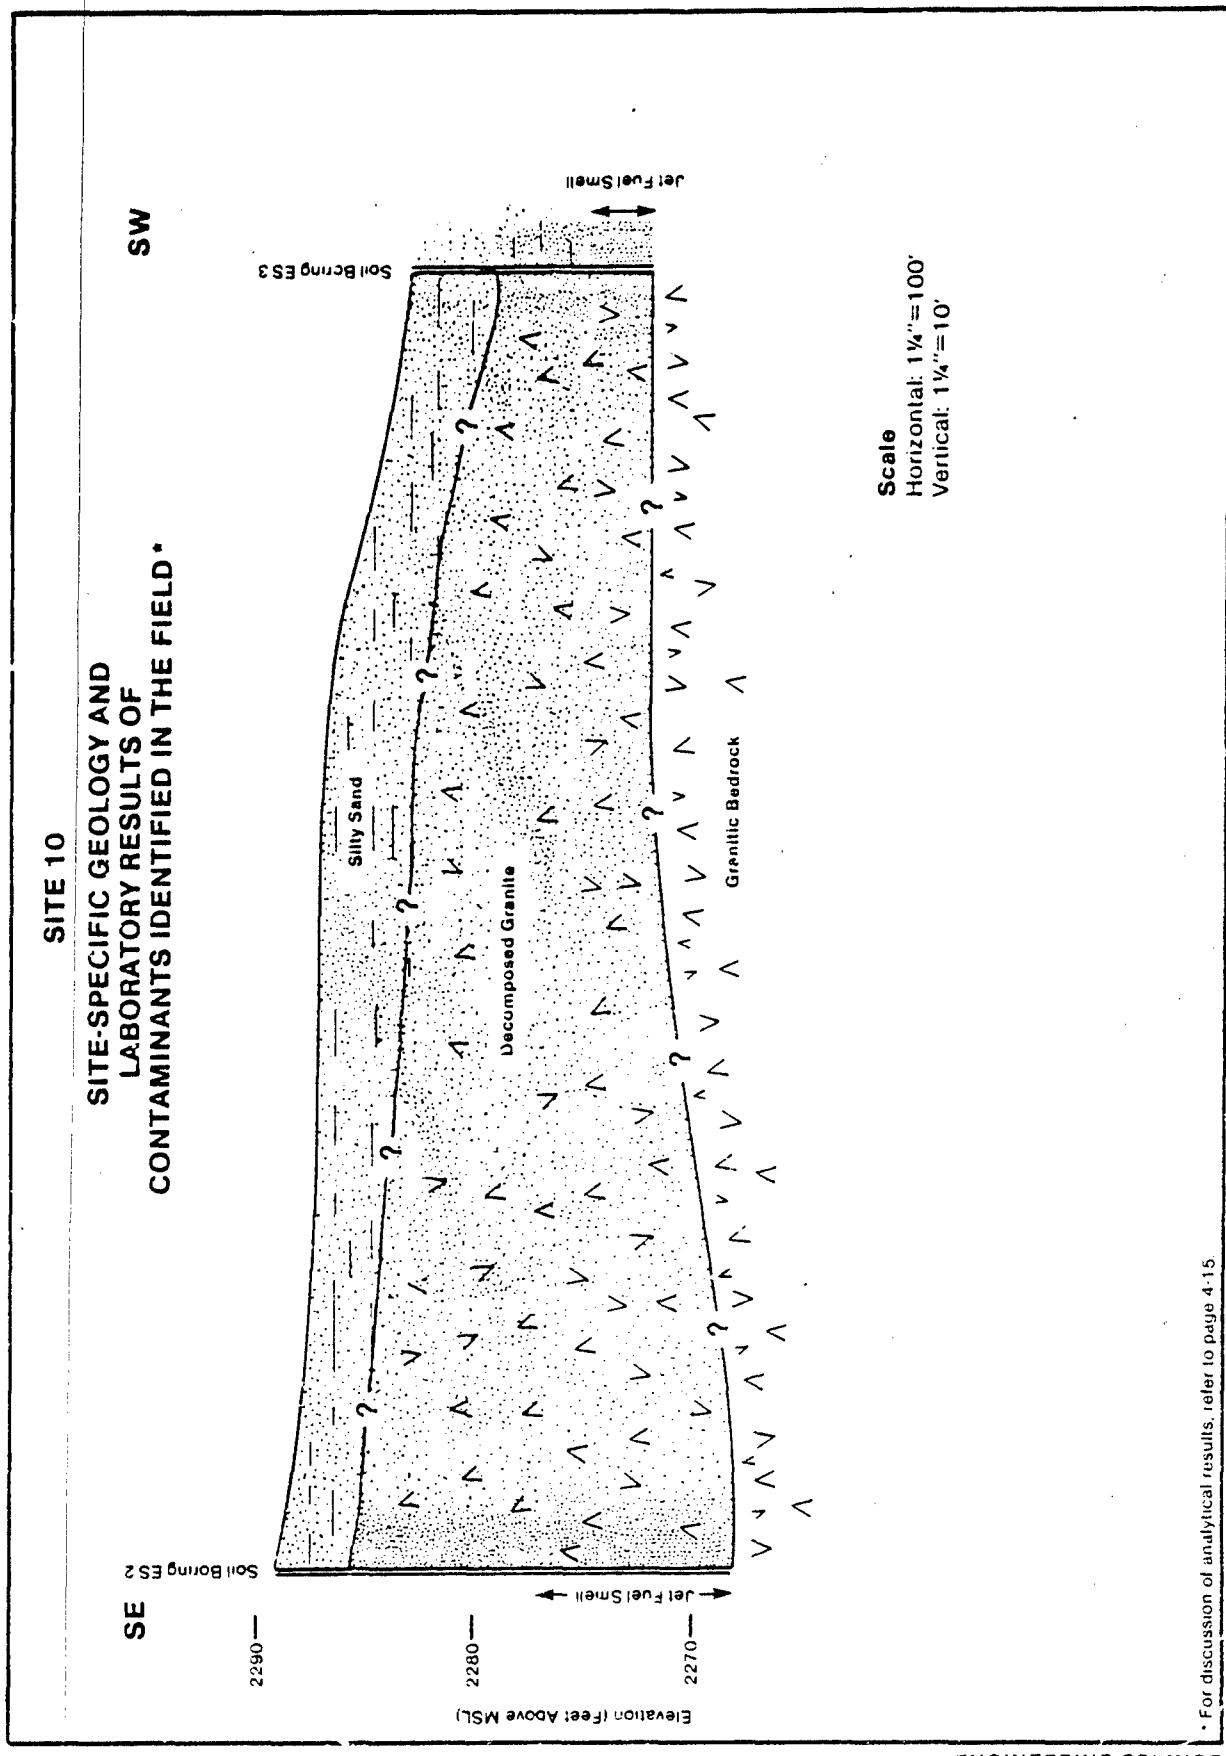
FIGURE 4.10

Following development of all the monitoring wells, water level measurements were taken and each well site was surveyed by the Base for determination of ground level elevation. Using these data, groundwater table contours were developed for the shallow groundwater table at the Main Base and South Base (Figure 4.10). When comparing regional groundwater elevation contours from Figure 2.3 with the shallow groundwater table on Figure 4.10, significant differences are noticeable. The shallow groundwater table is present at elevations ranging from 2,239 feet to 2,250 feet above mean sea level (msl), whereas the water table in Figure 2.3 shows an elevation of 2,225 feet above msl. In the vicinity of Site 5, the shallow groundwater table exhibits a steep gradient to the east, whereas the regional flow in Figure 2.3 is to the south-southeast toward the groundwater trough south of the South Base. Therefore, if leakage from underground tanks at Site 5 reached the shallow groundwater table, migration would most likely be eastward toward Rogers Dry Lake. This could explain the analytical results obtained for the groundwater samples south of Site 5. Monitoring well ES6 was installed to identify potential migration of fuel from 9N/9W-6E1. However, based on the newly developed shallow groundwater table contours, migration would occur toward the southeast rather than to the south. If fuel were migrating downgradient from 9N/9W-6E1 it would migrate southeasterly according to the local shallow groundwater gradient and thus would not be expected to be present in ES6.

Examination of the shallow groundwater table contours on Figure 4.10 shows a groundwater gradient that indicates a possible mound under Site 8. This could mean that some seepage from the pond into the groundwater has taken place.

At the Main Base, two monitoring wells were installed downgradient from the fuel hydrant spill. Both ES4 and ES10 are located in the downgradient direction of the shallow groundwater table (see Figure 4.10).

Figure 4.10 indicate an increase in gradient adjacent to the pond, seepage from the pond may have occurred. Considering the physical characteristics of the playa deposits underlying Site 8, however, the potential for groundwater contamination from pond seepage appears low. The bottom sediments within the sand itself are probably quite impermeable providing an effective barrier for contaminant migration. There is no information on groundwater quality near the site.

To determine potential groundwater contamination, a monitoring well should be installed immediately downgradient of the pond in the shallow groundwater, and a water sample retrieved and analyzed for metals and organic solvents. An undisturbed soil sample should be obtained for permeability testing.
